**I-90 MP 16.21 Unnamed Tributary to Tibbetts Creek
(WDFW ID: 991182)**

Preliminary Hydraulic Design Report

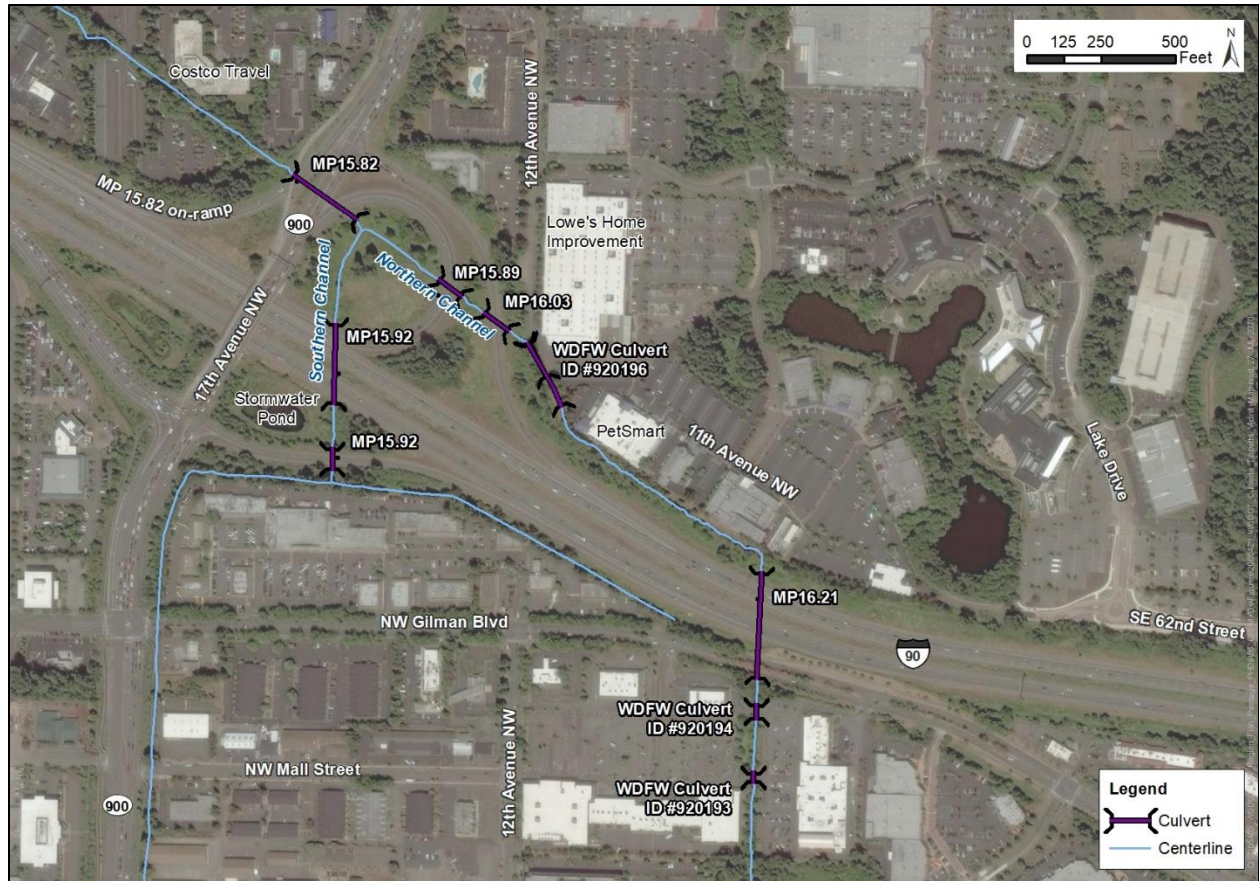
Figure 2: Zoomed-in vicinity map of the Unnamed Tributary to Tibbetts Creek in the I-90 and SR 90 interchange area

I-90 crosses the northern channel of the Unnamed Tributary to Tibbetts Creek, also referred to as Pickering Creek, approximately 0.5 miles upstream of its confluence with the southern Unnamed Tributary in the I-90 and SR 900 interchange (Figure 2). Since coordination is required between crossings I-90 MP 16.21, I-90 MP 16.03, I-90 MP 15.82, I-90 MP 15.89, I-90 MP 15.92 and I-90 EB Ramp MP 15.92, and all crossings are technically on “Unnamed Tributary to Tibbetts Creek” the northern channel and southern channel distinction was made (Figure 2). The channel crosses I-90 0.8 miles upstream of its confluence with Tibbetts Creek and 1.2 miles from Tibbetts Creek mouth where it enters Lake Sammamish. The watershed of the contributing basin above the project crossing was delineated from known stormwater routing system information in the highly urbanized area. The contributing basin (Figure 3) has an area of about 0.41 square miles with a maximum elevation of 387 feet in the basin uplands and descends to about 50 feet at the crossing. The overall basin has gentle slopes with an average basin slope of six percent. The creek is channelized through a commercialized urban corridor for most of its length with limited floodplain accessibility until the confluence with Tibbetts Creek. According to an analysis of the available aerial imagery, the stream was channelized before 1936, flowing through what was mostly cleared farmland until basin-wide urban development began in earnest during the 1980s. The channel was realigned downstream of I-90 in the 1980s from its original route along what is now 11th Avenue to its current corridor along I-90 westbound. Based on the National Land Cover Database (NLCD) dataset (Yang et al., 2018), landcover in the basin is dominated by urban development (90 percent), with 60 percent of that representing moderately to highly developed areas, and the remaining 10 percent occupied by mixed forest and herbaceous plants, most of which is in the residential area in the upper basin. On average, 41.4 inches of precipitation falls on the basin annually (PRISM Climate Group, 2019).

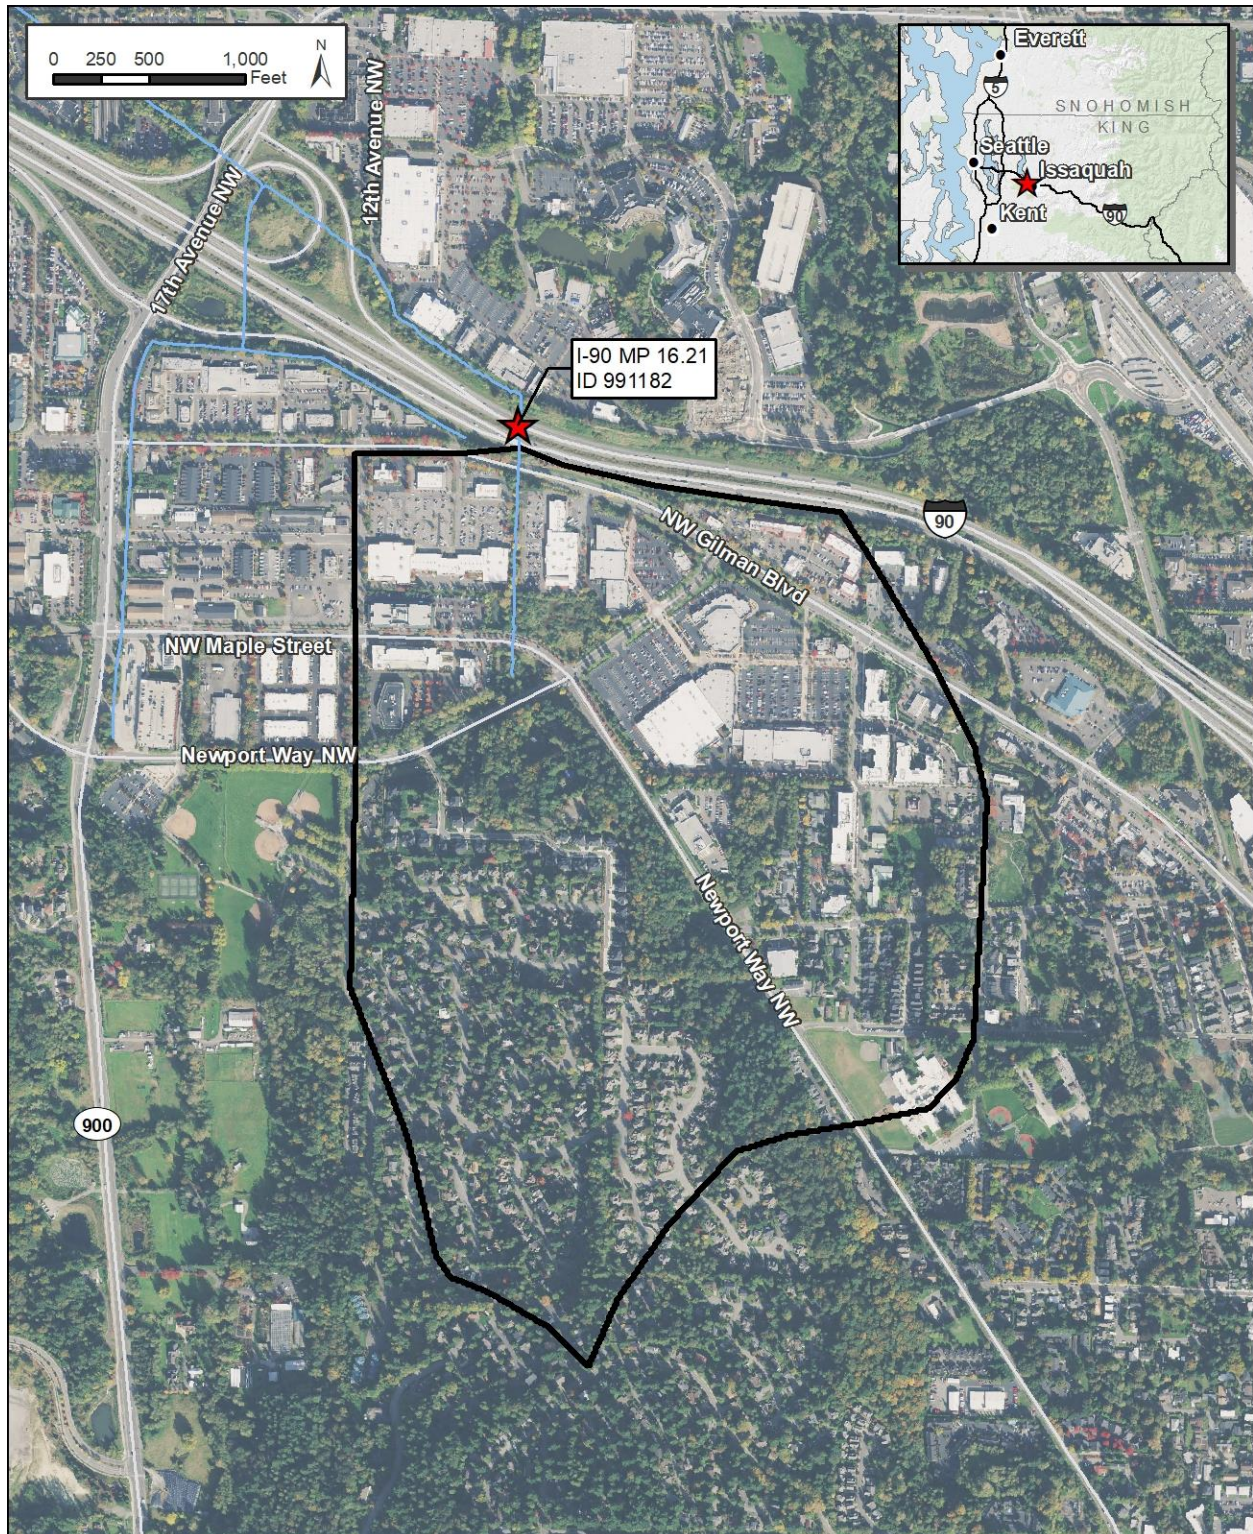
Figure 3: Basin land use in the northern Unnamed Tributary to Tibbetts Creek

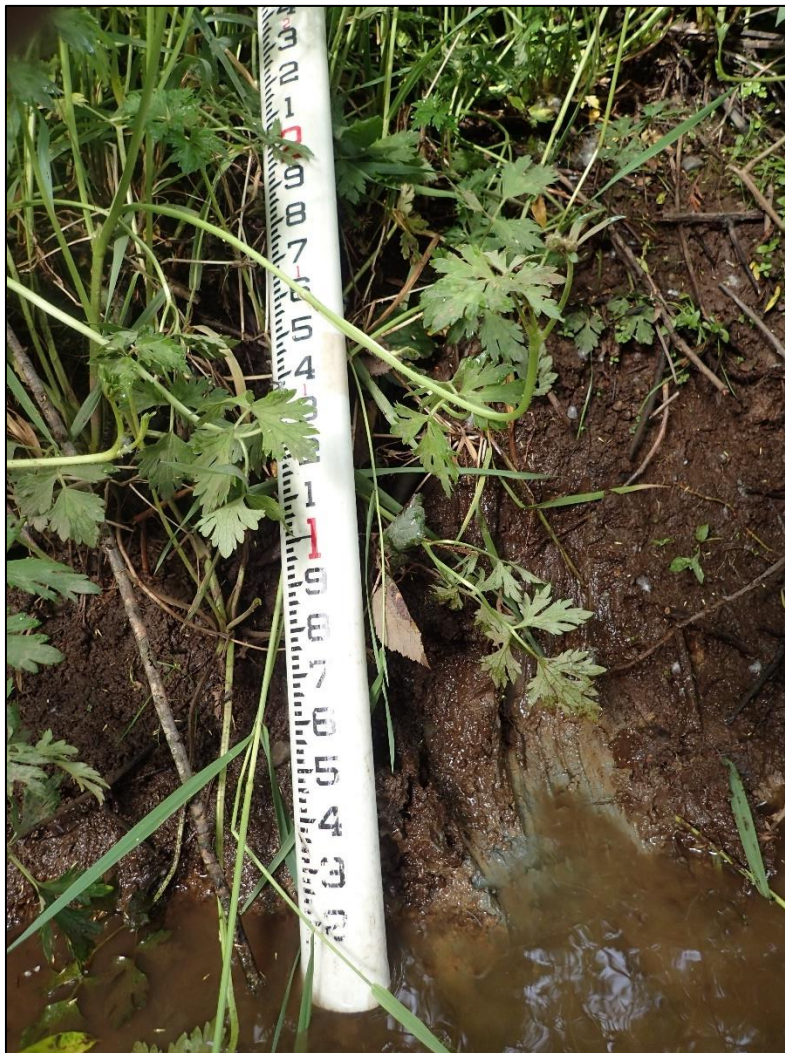
Figure 4: View of clay material that defines the bed and banks downstream of I-90

by anthropogenic alterations to the landscape. Glacial drift deposits and glacial till from the most recent glacial advance define the hillslopes in the upper basin of the tributary. During the Vashon advance of the Fraser glaciation, ice flowed from British Columbia into the Puget Lowlands to form the Puget lobe of the Cordilleran ice sheet (Booth et al., 2002). Ice contact deposits represent deposition against stagnant melting ice in the glacial Lake Sammamish trough and are found in the highlands of the basin. The drift deposits consist of a high percentage of silt intermixed with granular sediments that result in poorly sorted stratified sediment. The lowlands of the greater Tibbetts and Issaquah Creek basins are characterized by low gradient alluvial and wetland deposits forming since the retreat of the glaciers after the last ice age (Booth et al., 2012). The headwaters of the Unnamed Tributary appear to begin in the basin lowlands of mostly bog and peatland deposits, flowing through a very narrow urban corridor in the mapped peatland deposits until the crossing under I-90, after which the stream flows through modified alluvium along I-90. Bogs regularly overly impermeable clay layers, which prevents drainage into groundwater. This clay layer is exposed in the bed and banks downstream of I-90 (Figure 4).

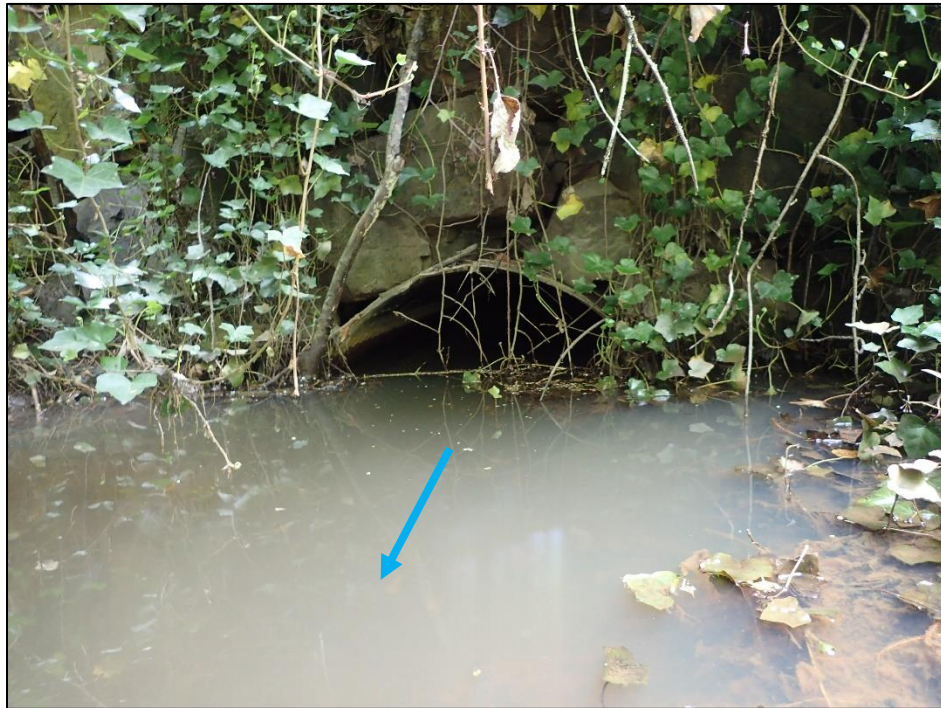
Figure 5: View of culvert 80 feet upstream of the project culvert inlet (WDFW ID# 920193) and the gray coloring characteristic of stormwater runoff (blue arrow indicates flow direction) (Station 13+80)

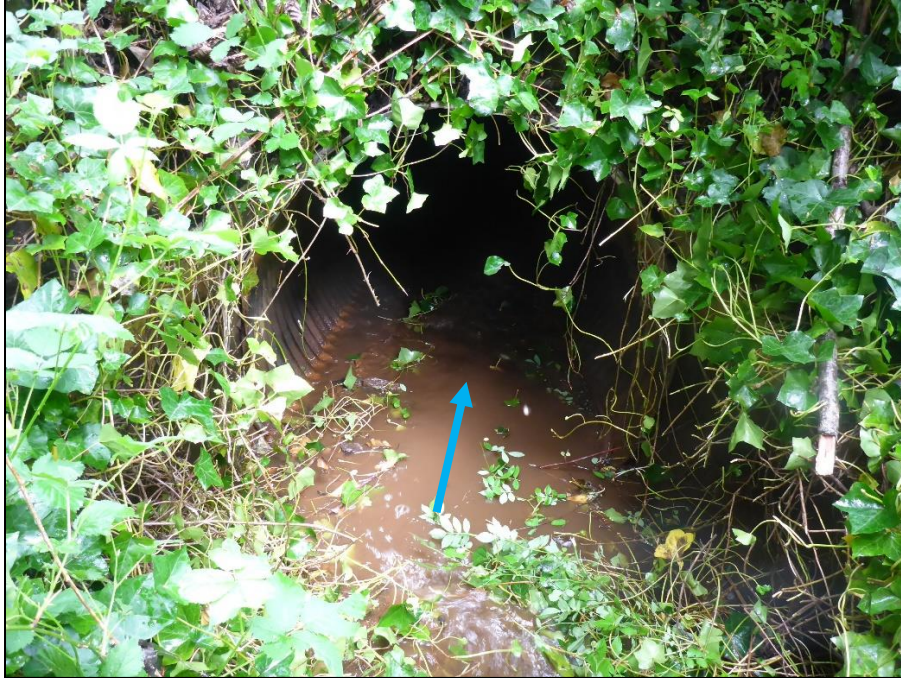
Figure 7: Existing conditions at the I-90 culvert inlet (blue arrow shows flow direction) (Sta. 13+80)

The existing structure consists of a 376-foot long, 4-foot diameter single broken-back corrugated metal culvert at a 0.56 percent slope (Figure 7). The culvert includes a manhole approximately eight feet downstream from the inlet that allows a second 4-foot diameter culvert to enter the Unnamed Tributary to Tibbetts Creek. The second culvert also occurs at a slope break, creating the broken back. The source of that culvert drains the developed area to the east and is the primary closed conveyance for Issaquah Creek overflows. There is an additional 4-foot diameter culvert 60 feet upstream of the crossing (Figure 8). The project culvert crosses under Gilman Boulevard and I-90 before daylighting downstream. The outlet has a wing wall and there is a small ditch entering from the east (Figure 9). The outlet has formed a scour pool that is approximately three feet below typical grade.

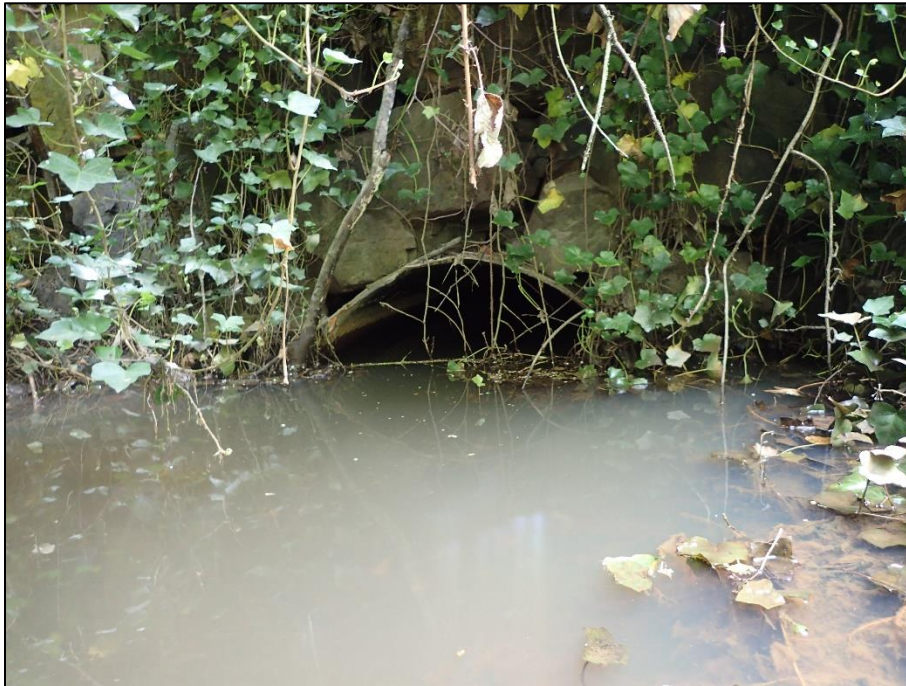
Figure 8: Outlet of WDFW culvert 920193 (Sta. 14+50)

90. This tributary conveys stormwater from the surrounding urban area, causing gray discoloration of the stream water (Figure 8).

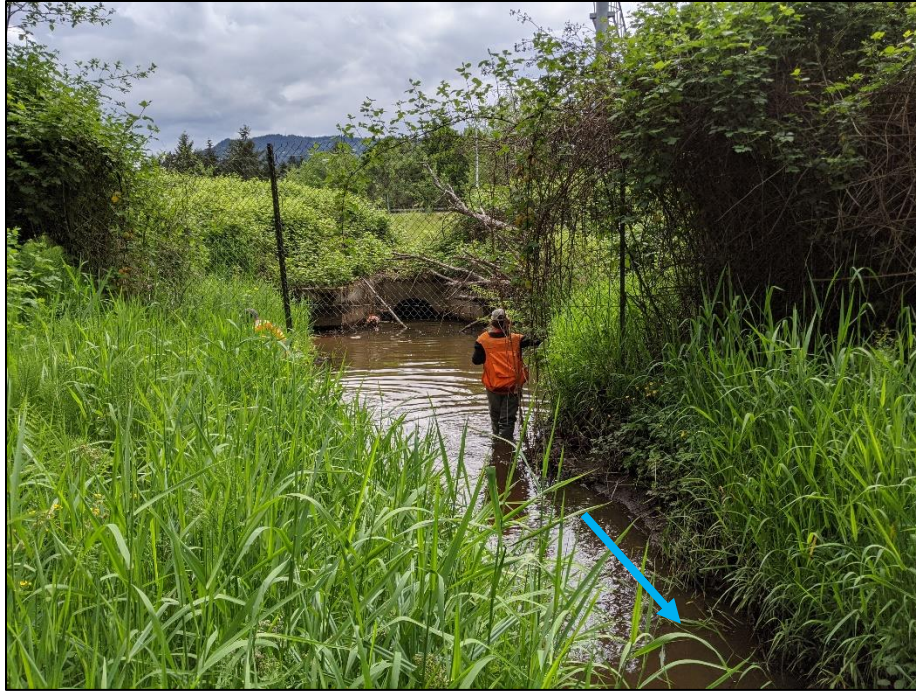
Figure 9: Existing conditions at the I-90 culvert outlet (blue arrow shows flow direction) (Sta. 10+00)

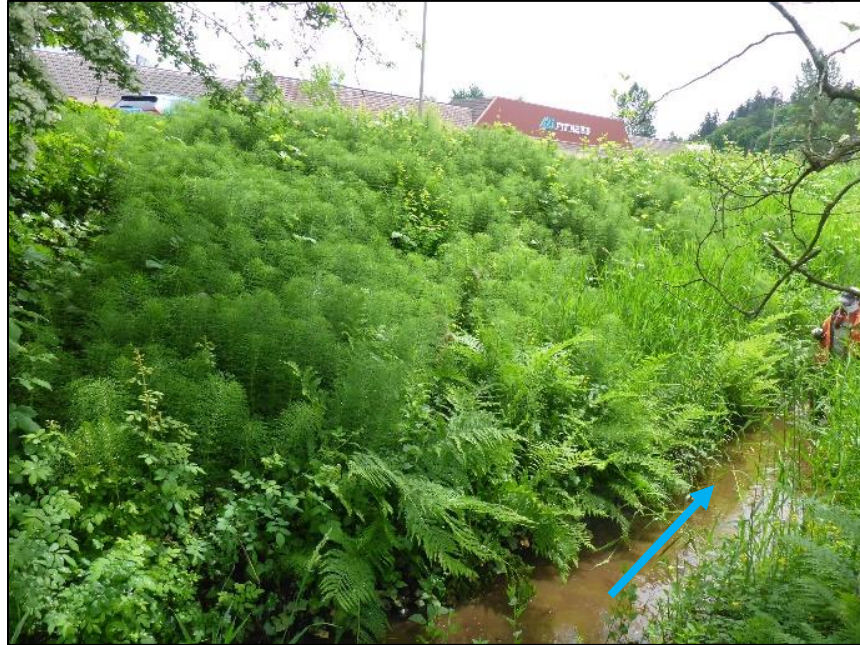
Figure 10: View of confined northern unnamed tributary to Tibbetts Creek corridor upstream of Culvert 920194 (blue arrow indicates flow direction)

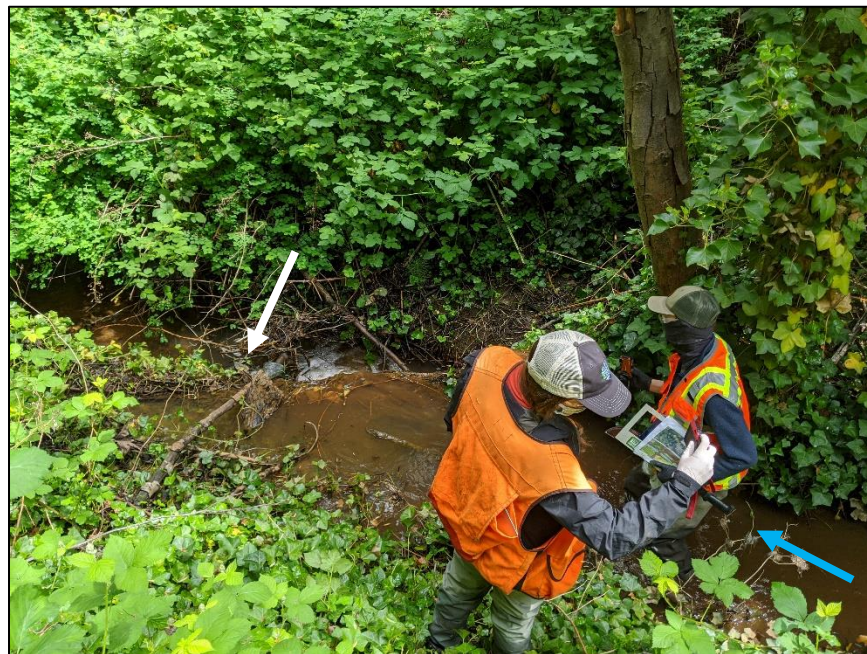
Figure 11: Channel conditions in the reach between the I-90 culvert inlet and Culvert 920193 (blue arrow indicates flow direction, white arrow indicates wood jam) (Sta. 14+02)

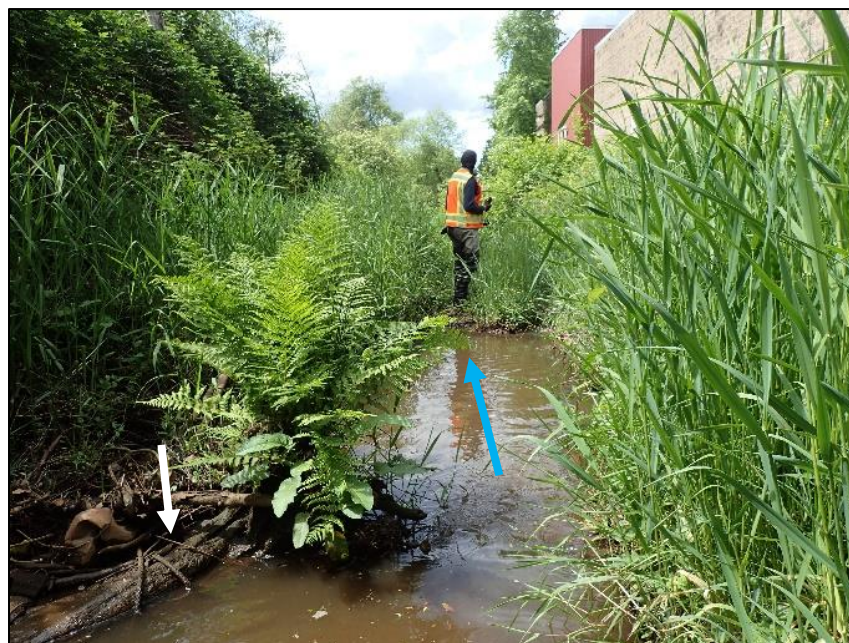
Figure 12: View of channel corridor 100 feet downstream of I-90 culvert outlet, with Big Lots bordering the right bank and I-90 westbound off ramp on the left bank behind dense blackberry (blue arrow indicates flow direction, white arrow points to anchored wood on the bank)

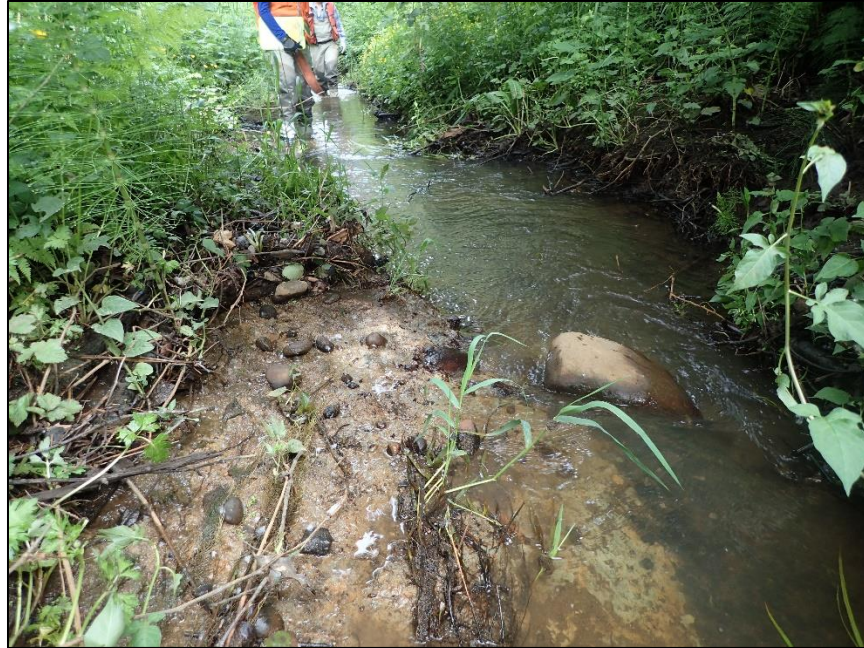
Figure 13: Exposed clay bed with little alluvial cover downstream of I-90 (Sta. 03+50)

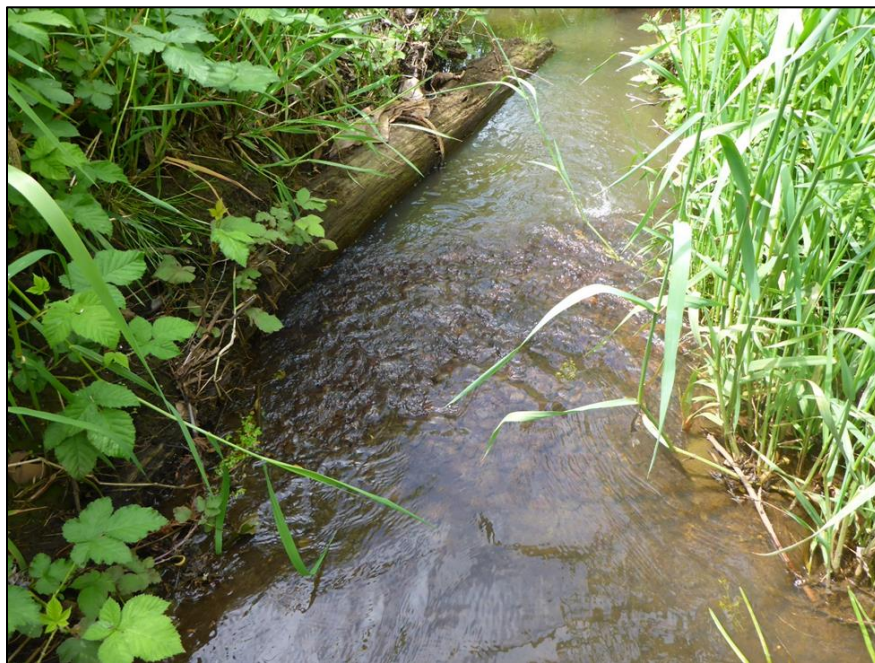
Figure 14: Example of riffle-glide morphology through the restoration reach (Sta 03+97)

Sediment supply to the crossing consists of mostly fine material and small gravel (Section 2.8.3). The quantity of sediment based on the site visit appears to be sufficient to form deposits and bars (Figure 14).

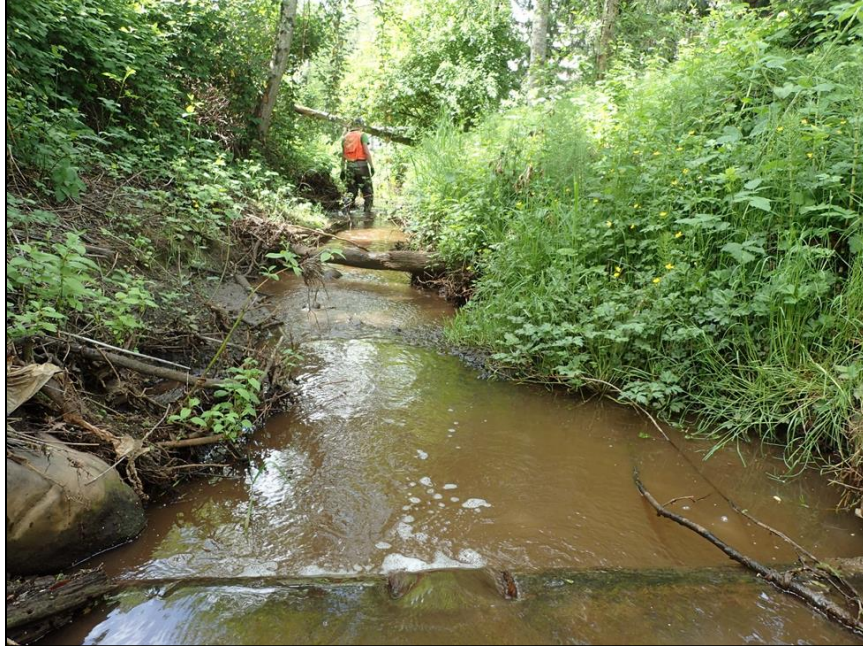
Figure 15: Notched log weir structure under shaded canopy (Sta. 03+16)

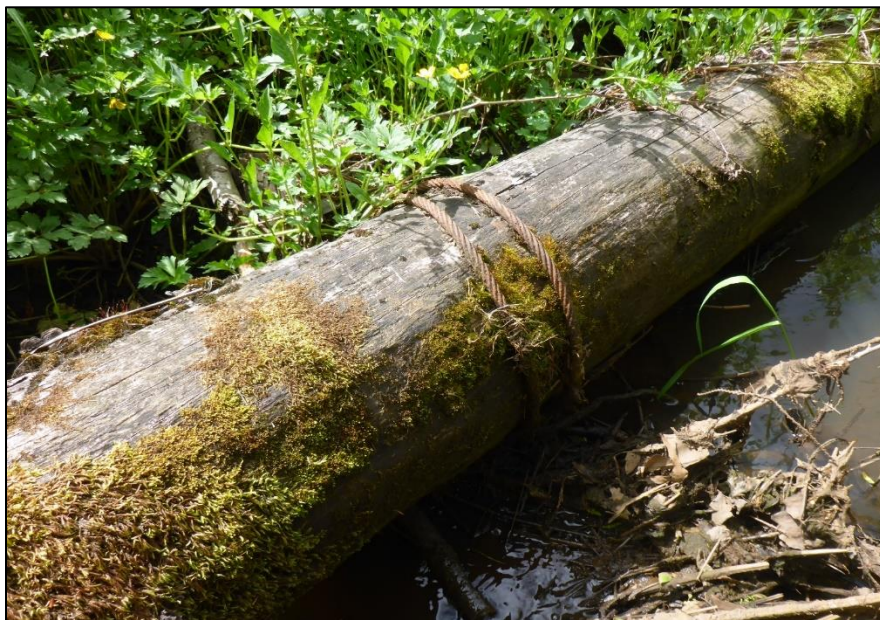
Figure 16: Typical anchoring on LWM through the restoration reach (Sta. 01+75)

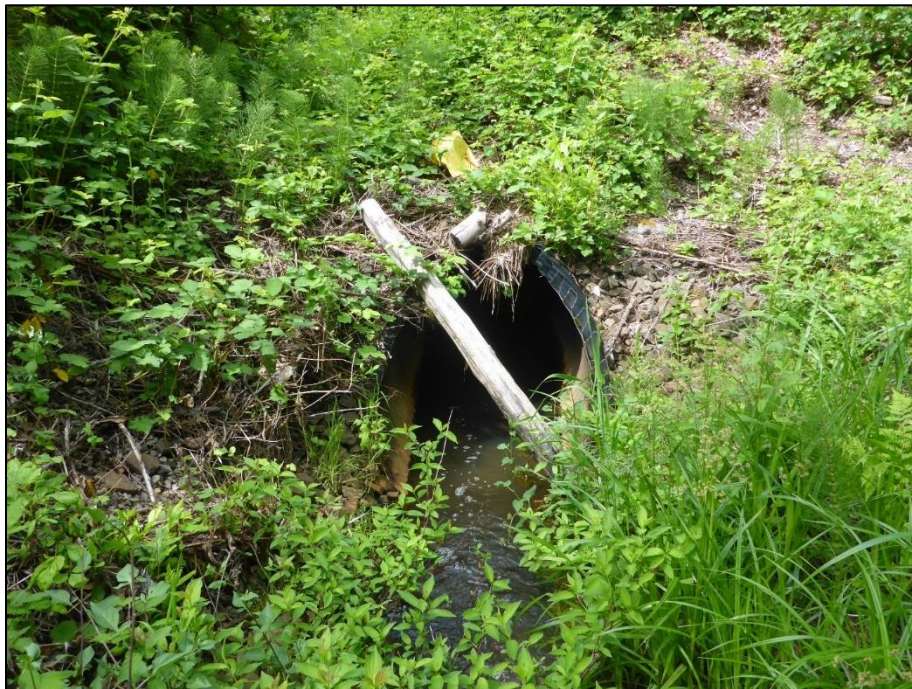
Figure 18: Downstream city culvert WDFW ID 920196 (Sta 00+00)

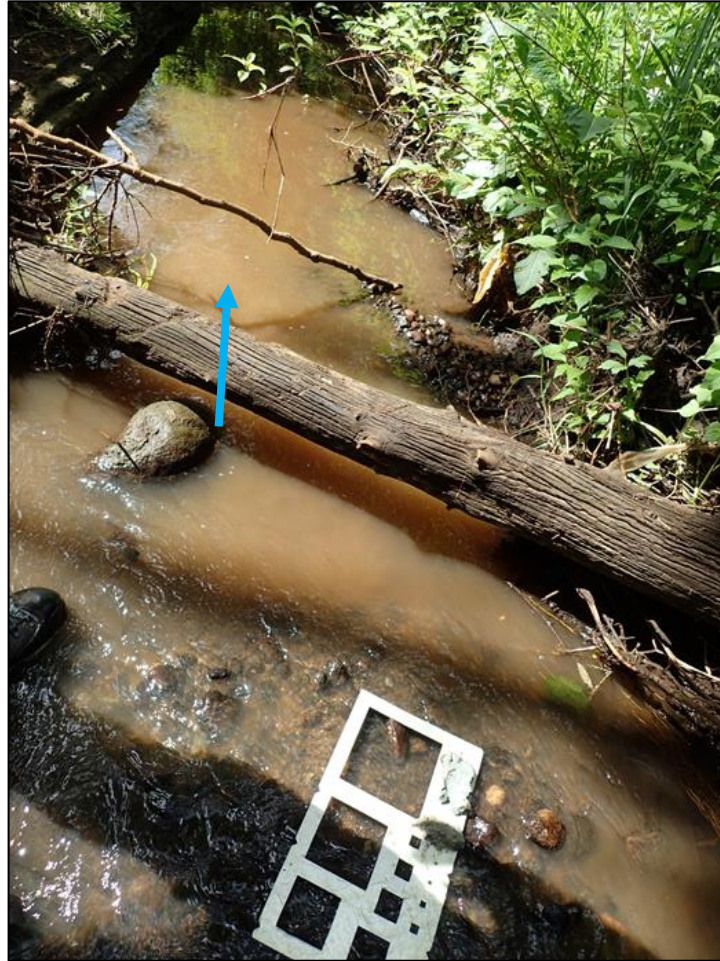
Figure 21: Photo of natural wood and characteristic coarse grains of a riffle bed in the reference reach at Sta. 04+45 (blue arrow indicates flow direction)

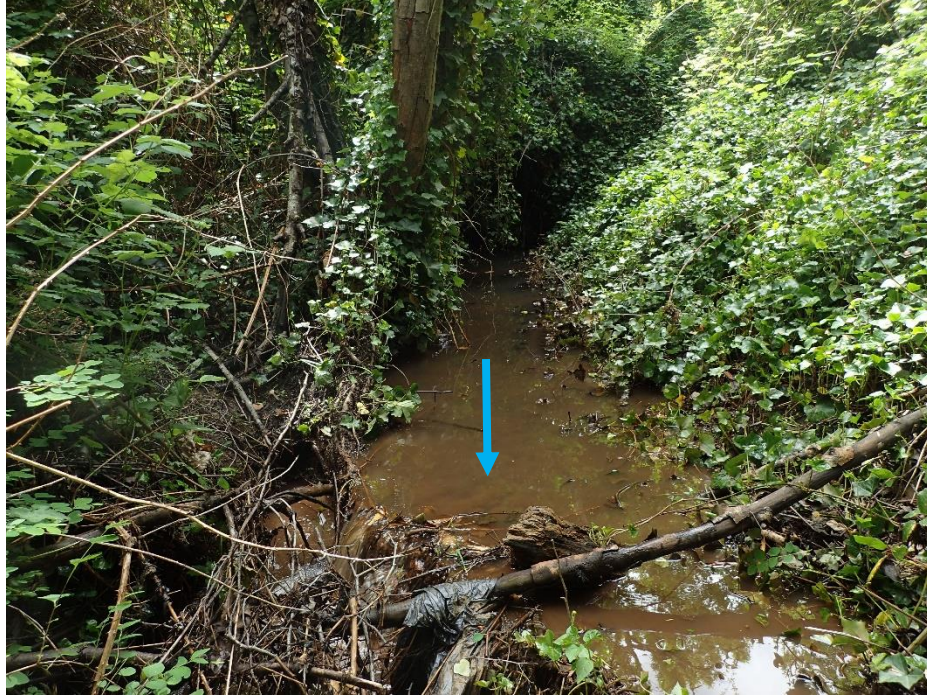
Figure 22: Channel conditions upstream of I-90 culvert (blue arrow shows flow direction) (Sta. 14+02)

The northern channel of the Unnamed Tributary to Tibbetts Creek is a mostly straight channelized stream above I-90 at a gradient of 0.5 percent. The creek is currently entrenched and laterally confined by vegetated steep overbank slopes within a narrow 60-ft urban corridor. Average BFW between the I-90 culvert and WDFW Culvert ID 920193 is five feet accompanied by steep banks, yielding a channel width to depth ratio of 5:2 in this 60-ft long reach (Figure 22, Station 14+30 in Figure 23). Overbank slopes are slightly shallower upstream of WDFW Culvert ID 920194 and BFW increases to six feet in the reach encroached by reed canary grass (Station 18+70 in Figure 23). Channel position is fixed upstream of I-90, confined by the steep embankments of the narrow corridor, resulting in a straight stream. The corridor lacks a channel bench upstream of I-90 to accommodate higher flows.

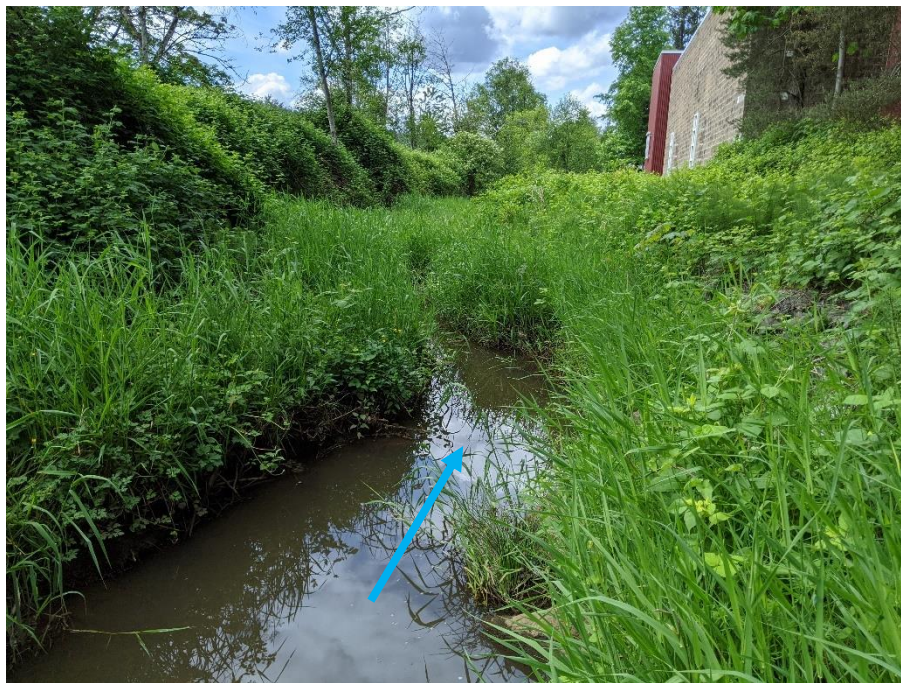
Figure 24: Channel conditions immediately downstream of I-90 culvert outlet (blue arrow indicates flow direction) (Sta. 09+50)

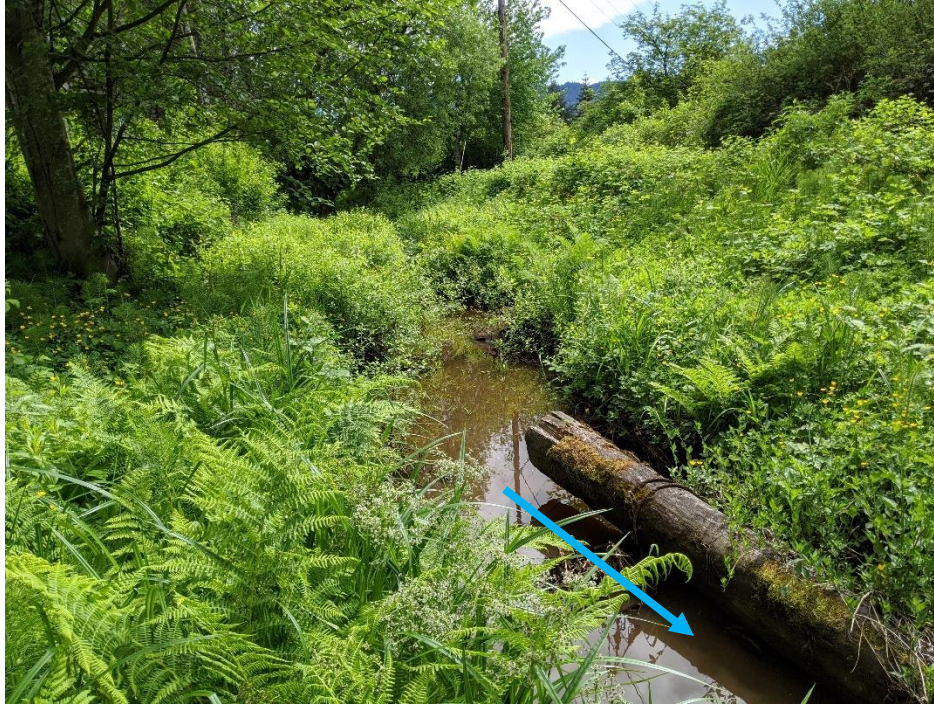
Figure 25: Channel conditions in the restored reach (blue arrow indicates flow direction) (Sta. 01+75)

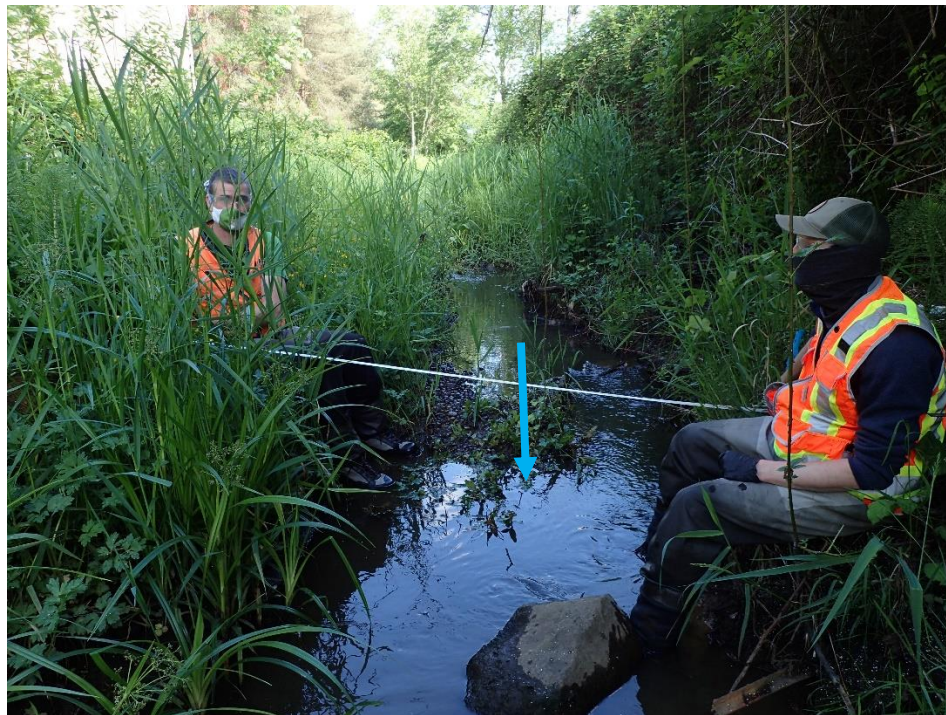
Figure 27 shows the location of BFW #1 downstream of I-90. This transect is in the upstream-most extent of the LWM restoration zone where riparian vegetation is restricted to reed canary grass and blackberry. The engineered LWM that was present in the channel was forcing small lateral gravel bars and local scour. The measurement was taken in a channel bend above a small boulder and NHC measured a BFW of eight feet.

Figure 27: BFW #1 at Station 08+00 (blue arrow indicates flow direction)

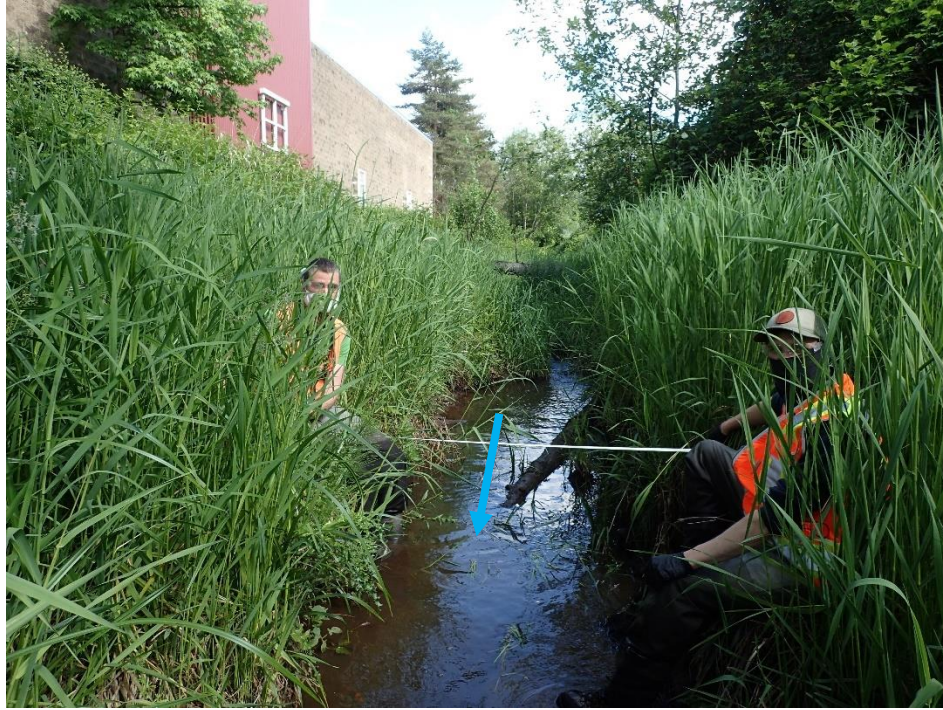
The second BFW measurement was taken about 70 feet downstream of BFW 1 in a straight glide reach (Figure 28). Bank slopes remain vertical and channel geometry consistent. NHC measured a channel width of nine feet in this location.

Figure 28: BFW #2 at Station 07+30 (blue arrow indicates flow direction)

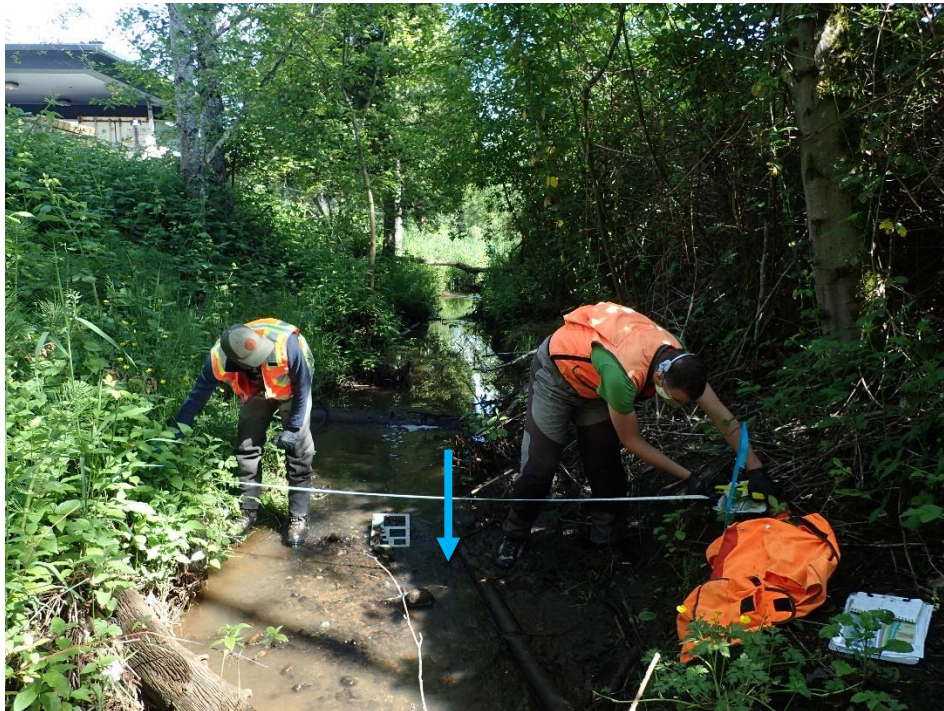
The third BFW measurement was taken in a log-weir-forced riffle in the more densely wooded riparian area of the reference reach located just downstream of the PetSmart building (Figure 29). The wood produces local scour on the bed and banks so that bank slopes are visibly shallower in this reach widening the channel. NHC measured BFW of 9.5 feet in this riffle.

Figure 29: BFW #3 measured at Station 04+50 (blue arrow indicates flow direction)

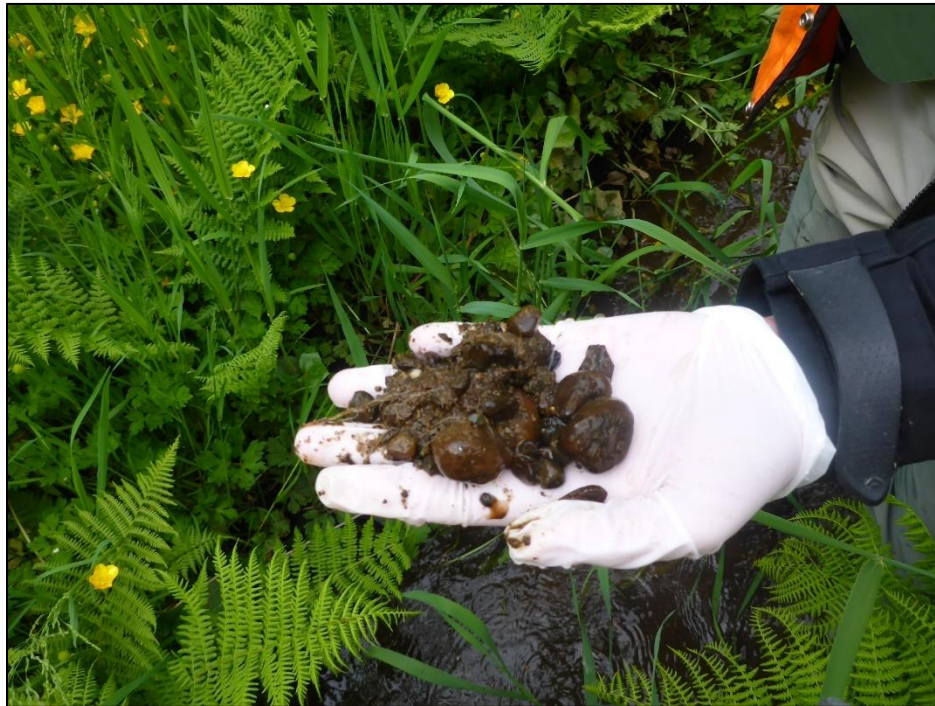
Figure 31: View of sandy gravel substrate at PC 1 Station 14+15

Most of the observable bed along the surveyed route was clay and fine sands or silt unless in areas of wood-forced riffle deposits, the frequency of which increases downstream of I-90 in the partially restored reach. NHC performed Wolman pebble counts on one riffle bed upstream of the crossing and three riffle-glide beds downstream to understand sediment transport efficiency throughout the reach. The first pebble count (PC 1) was taken 25 feet upstream of the I-90 culvert inlet in a 10-ft long riffle deposit. This sandy gravel deposit is a representation of the natural sediment supply available to the reach downstream of I-90 (Figure 31).

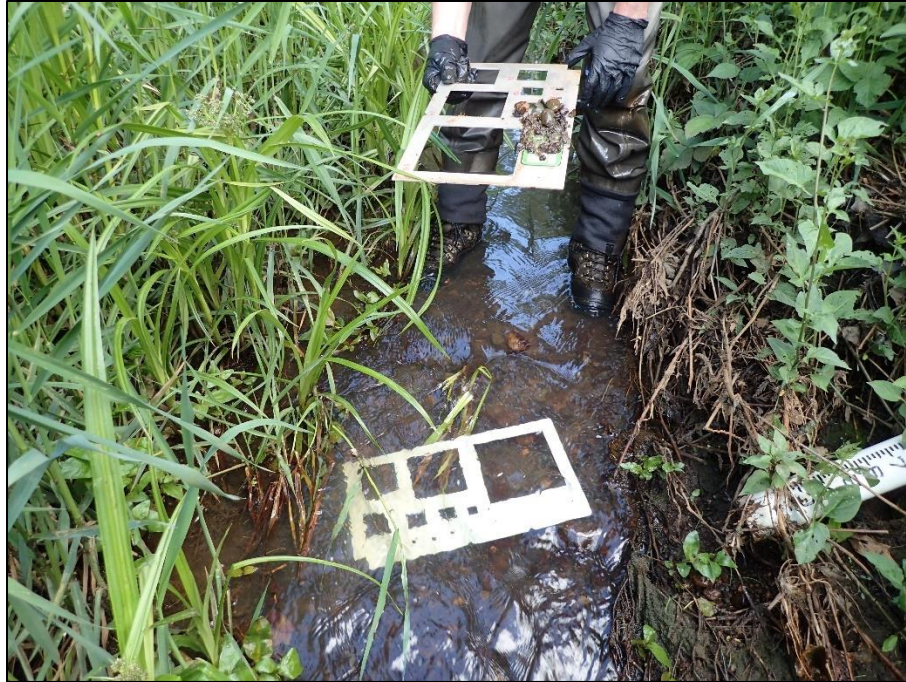
Downstream of the I-90 crossing, instances of wood-forced riffles increase as LWM becomes more abundant. Pebble Count 2 represents the bed surface of the first riffle observed downstream of I-90 at the upstream-most extent of the partially restored zone where channel width remains narrow and grass encroaches the channel bed (Figure 32).

Figure 32: View looking upstream at PC 2 Station 09+15 in narrow riffle

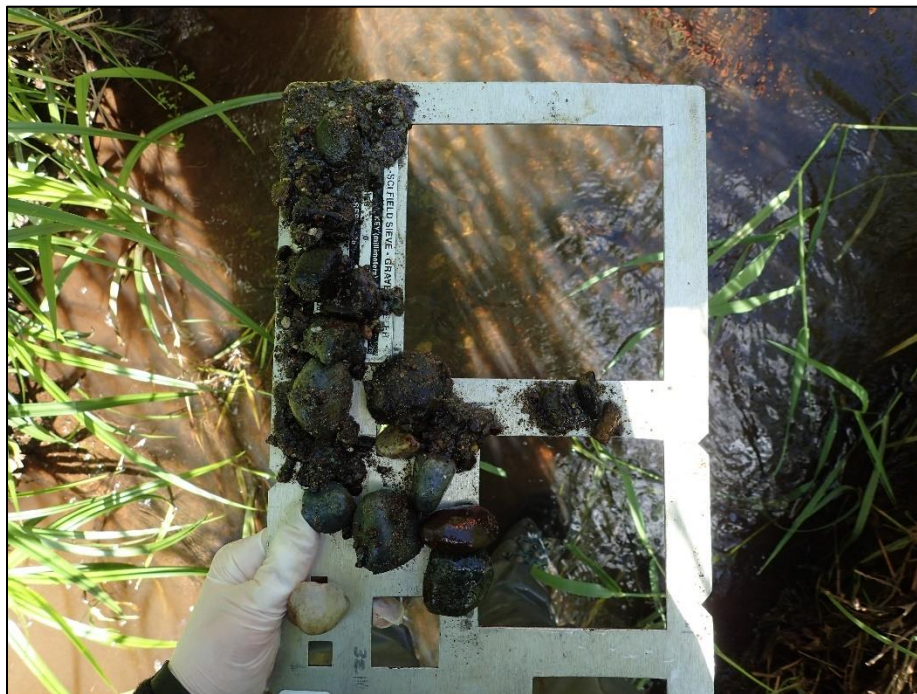
Pebble Count 3 was taken 315 feet downstream of the crossing in the reference reach in a wood-forced riffle bed. PC 3 was measured in the reference reach where the stream exhibits increased meandering and increased sediment storage in small lateral bars and behind channel logs. These riffle beds contain coarse gravel and small cobble that armor sand and fine gravel, all of which are pictured in Figure 33.

Figure 33: View looking at the riffle bed deposit of PC 3 at Station 07+05

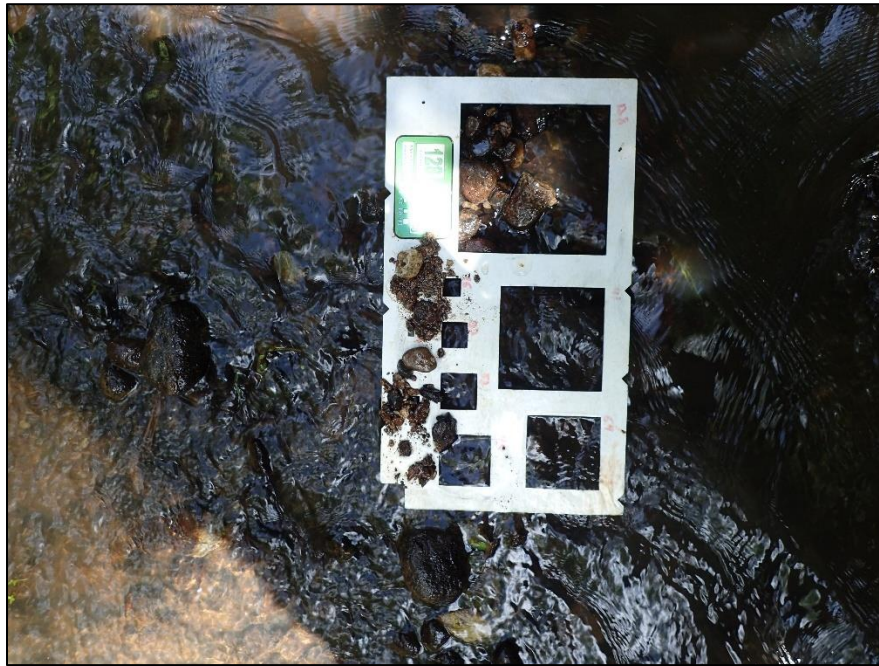
Pebble Count 4 was measured 500 feet downstream of the I-90 crossing in a riffle deposit formed by an engineered notched log weir. The channel corridor maintains a dense canopy of mature trees in this segment of the reference reach, which supplies the channel with additional natural wood (Figure 33).

Figure 34: View looking at riffle bed deposit of PC 4 (Station 04+45)

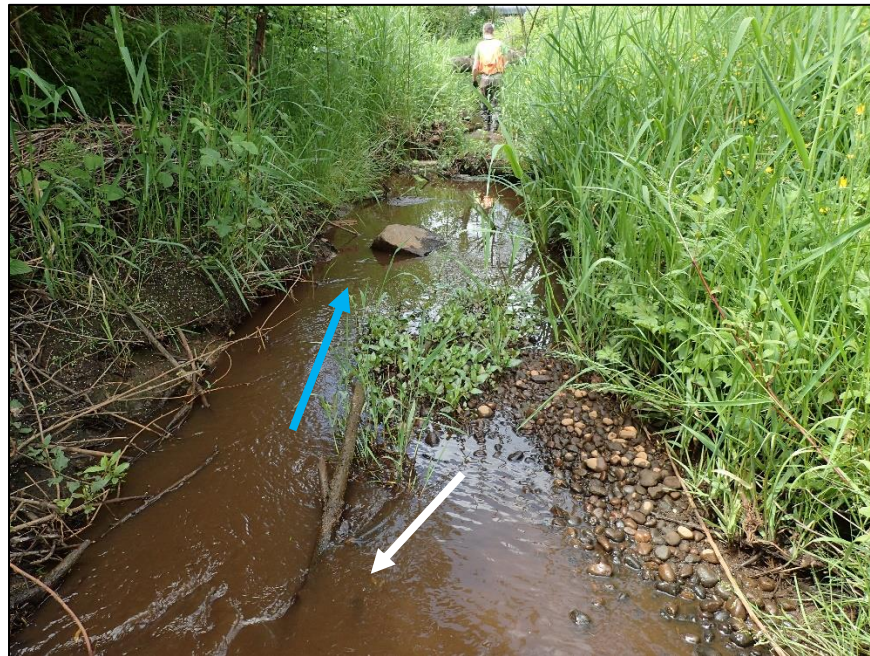
Figure 36: View of submerged LWM initiating gravel storage in small lateral bars and riffle-glide morphology (blue arrow indicates flow direction, white arrow points to submerged LWM) (Sta. 08+10)

The key grade controlling features observed along the reach are LWM, most of which have been engineered into the streambed and banks below the I-90 crossing. The only notable LWM observed above I-90 is the reach between WDFW culvert 920193 and the project culvert inlet where natural recruitment of wood from the dense canopy is possible. Downstream of I-90, anchored wood is common mostly on the banks with some submerged logs and log weirs present. Gravel accumulations were observed upstream of LWM. NHC interpreted the coarse gravel and small cobble deposits as channel bed armoring, currently protecting an underlying layer of finer gravel and sand alluvium that overly the local clay base. Local scour pools between one and two feet deep were observed in areas of instream LWM.

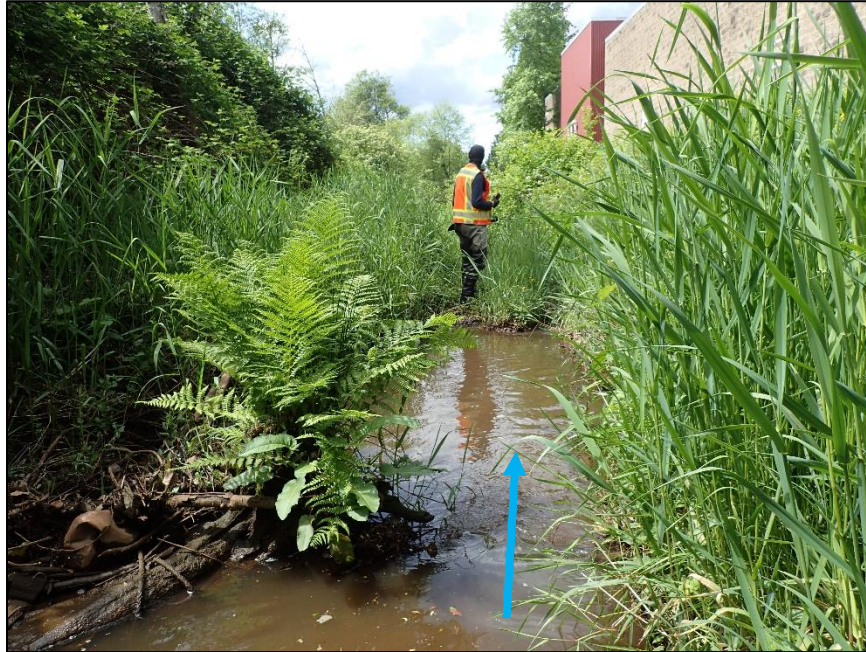
Downstream of I-90, the floodplain widens to 100 feet in width, laterally constrained by I-90 westbound on the left bank and commercial shopping stores on the right bank (Figure 38). The floodplain can therefore not expand. The channel exhibits greater sinuosity downstream of the crossing within a grassy channel bench. NHC measured sinuosity in the field of 1.1, defined as the length of the channel divided by the length of the flow corridor. The channel is expected to maintain sinuosity in the partially restored reach that contains LWM. This restored reach is expected to maintain active bank scouring and widening but remain constrained between the present infrastructural barriers. In the event of a large flood, such as 100-year overflow from Issaquah Creek, the channel is expected to migrate within the bounds of the

Figure 38: View of narrow floodplain corridor downstream of I-90 with Big Lots and other commercial stores on the right bank and I-90 west-bound behind the blackberry shrubs on the left bank (blue arrow indicates flow direction)
